## Technical Description of Ultrasound device

## Example Measurement made on an Audi (supposedly with overhauled motor)

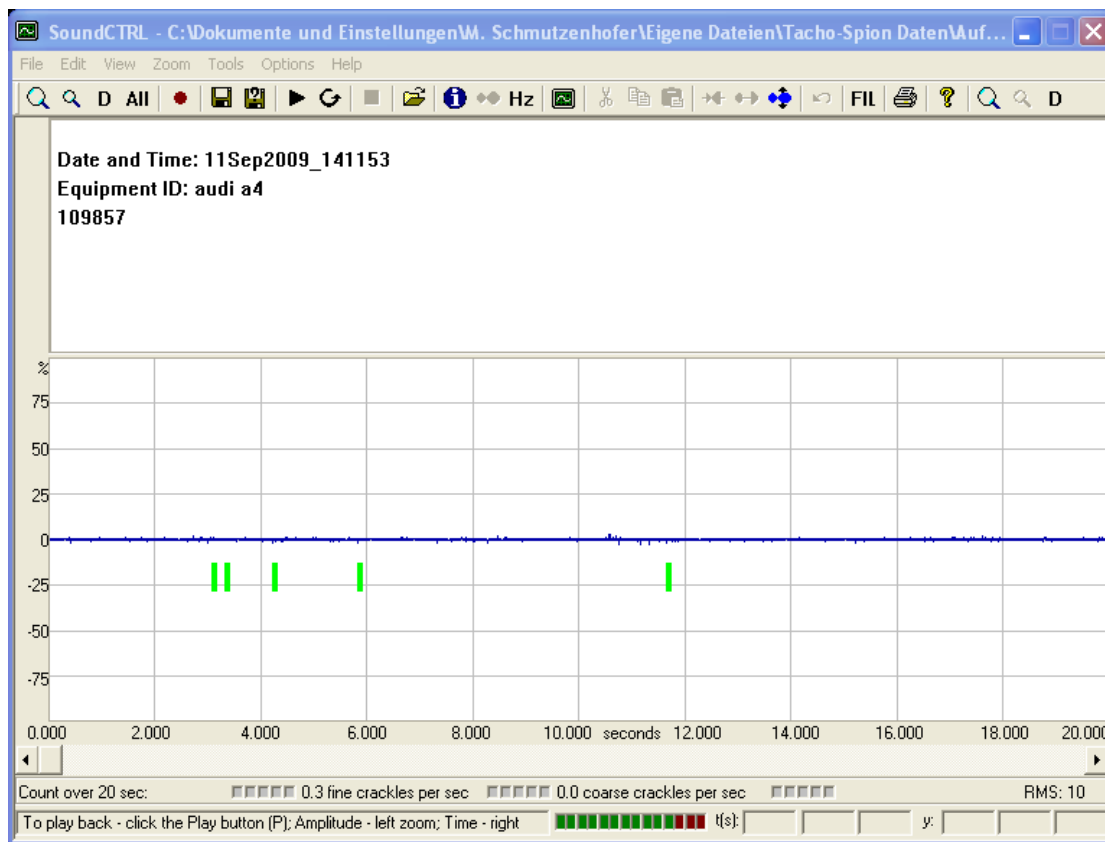
In this example one can see almost no change on the blue graph, the engine is in pristine condition

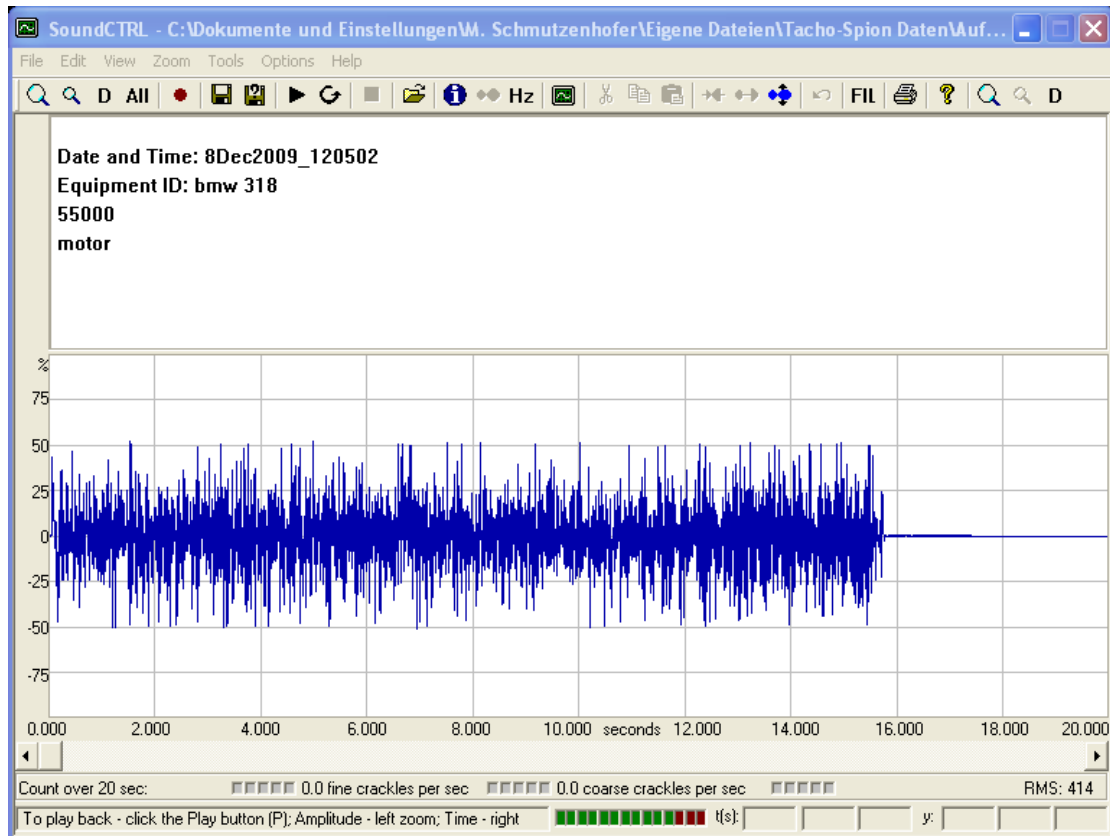
The difference of the condition in the two examples is obvious, but what does it translate to in the use of software?

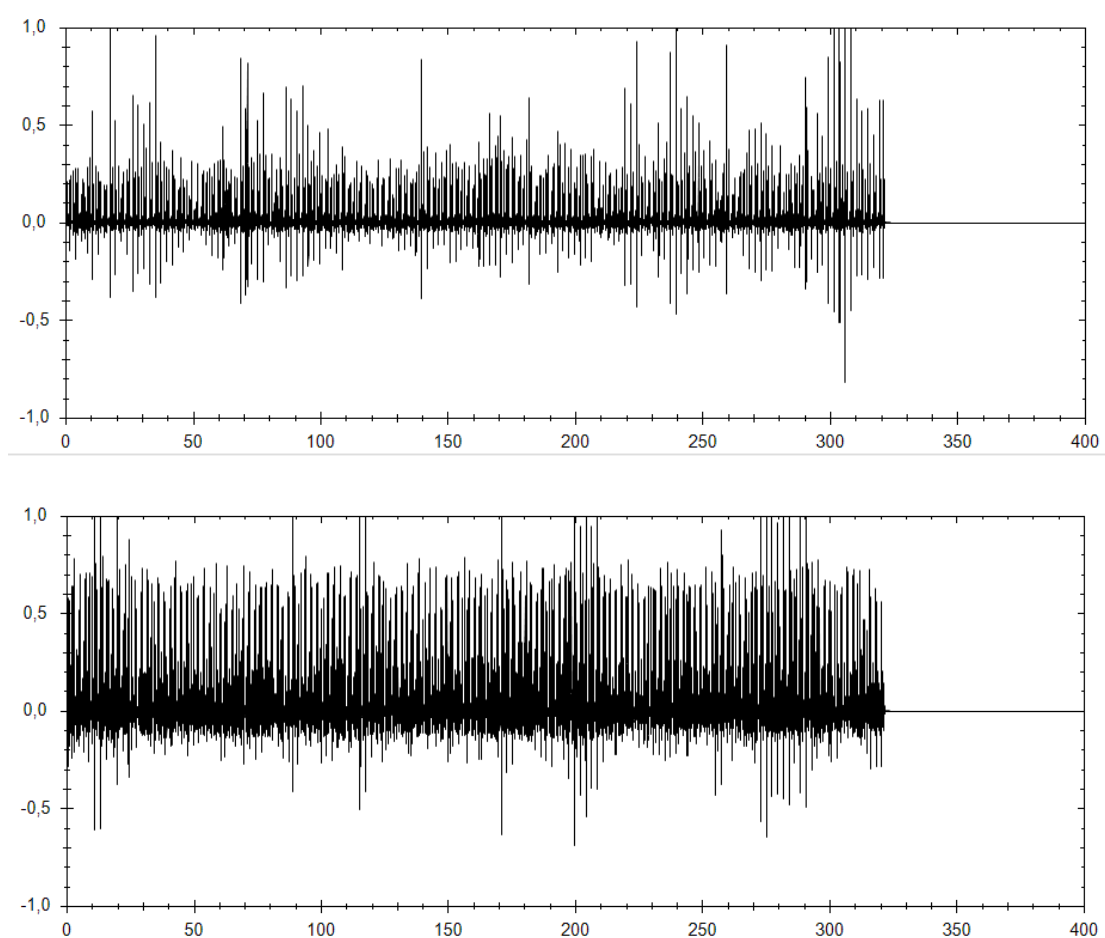
The RMS values were 74, 89, 143, RMS is Root Mean Square, the measuring units in Ultrasound spectrum.

The motor has a very high wear and tear and a very high risk of damage. An overhaul of the engine - as claimed by the mechanics - is very doubtful.

Further from the 3 measuring points, one is much higher than the others, therefore the area of the damaged part can be located, in the above case a worn camshaft was very likely.
