## Technical Description of Ultrasound device

## Example Measurement made on an Audi (supposedly with overhauled motor)

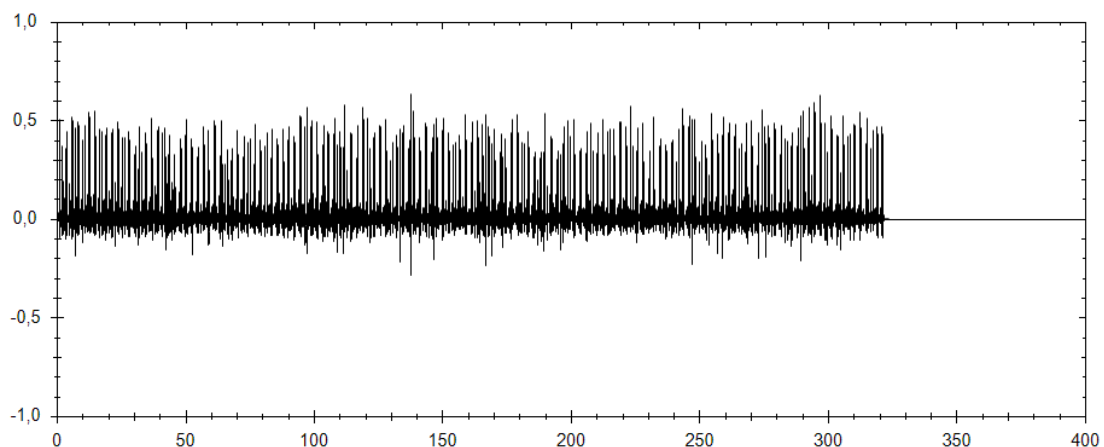
The RMS values were 74, 89, 143, RMS is Root Mean Square, the measuring units in Ultrasound spectrum.

The motor has a very high wear and tear and a very high risk of damage. An overhaul of the engine - as claimed by the mechanics - is very doubtful.

Further from the 3 measuring points, one is much higher than the others, therefore the area of the damaged part can be located, in the above case a worn camshaft was very likely.
